# New York State Department of Transportation

## PIA Safety Flag NB23U4W010

**BIN: 1065318**

**Feature Crossed: 6TH AVENUE**

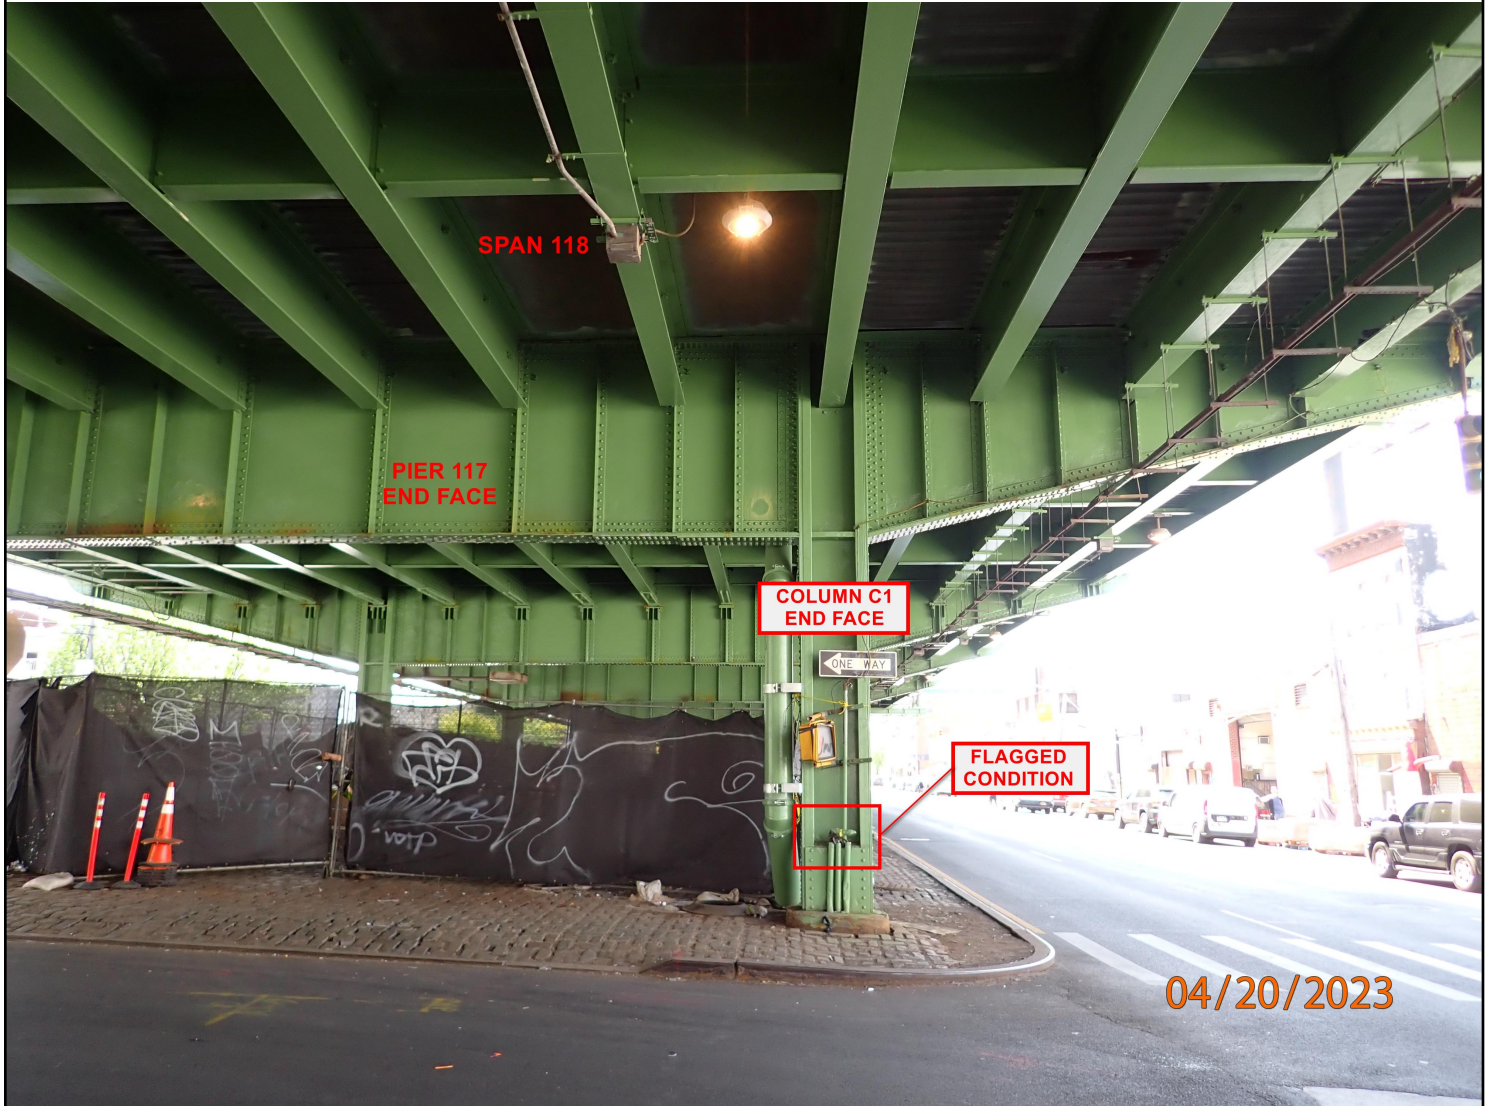
Photo Number: 2

**Attachment Description:** General view of the flagged condition under Span 118, column C1 at Pier 117. Looking Begin.

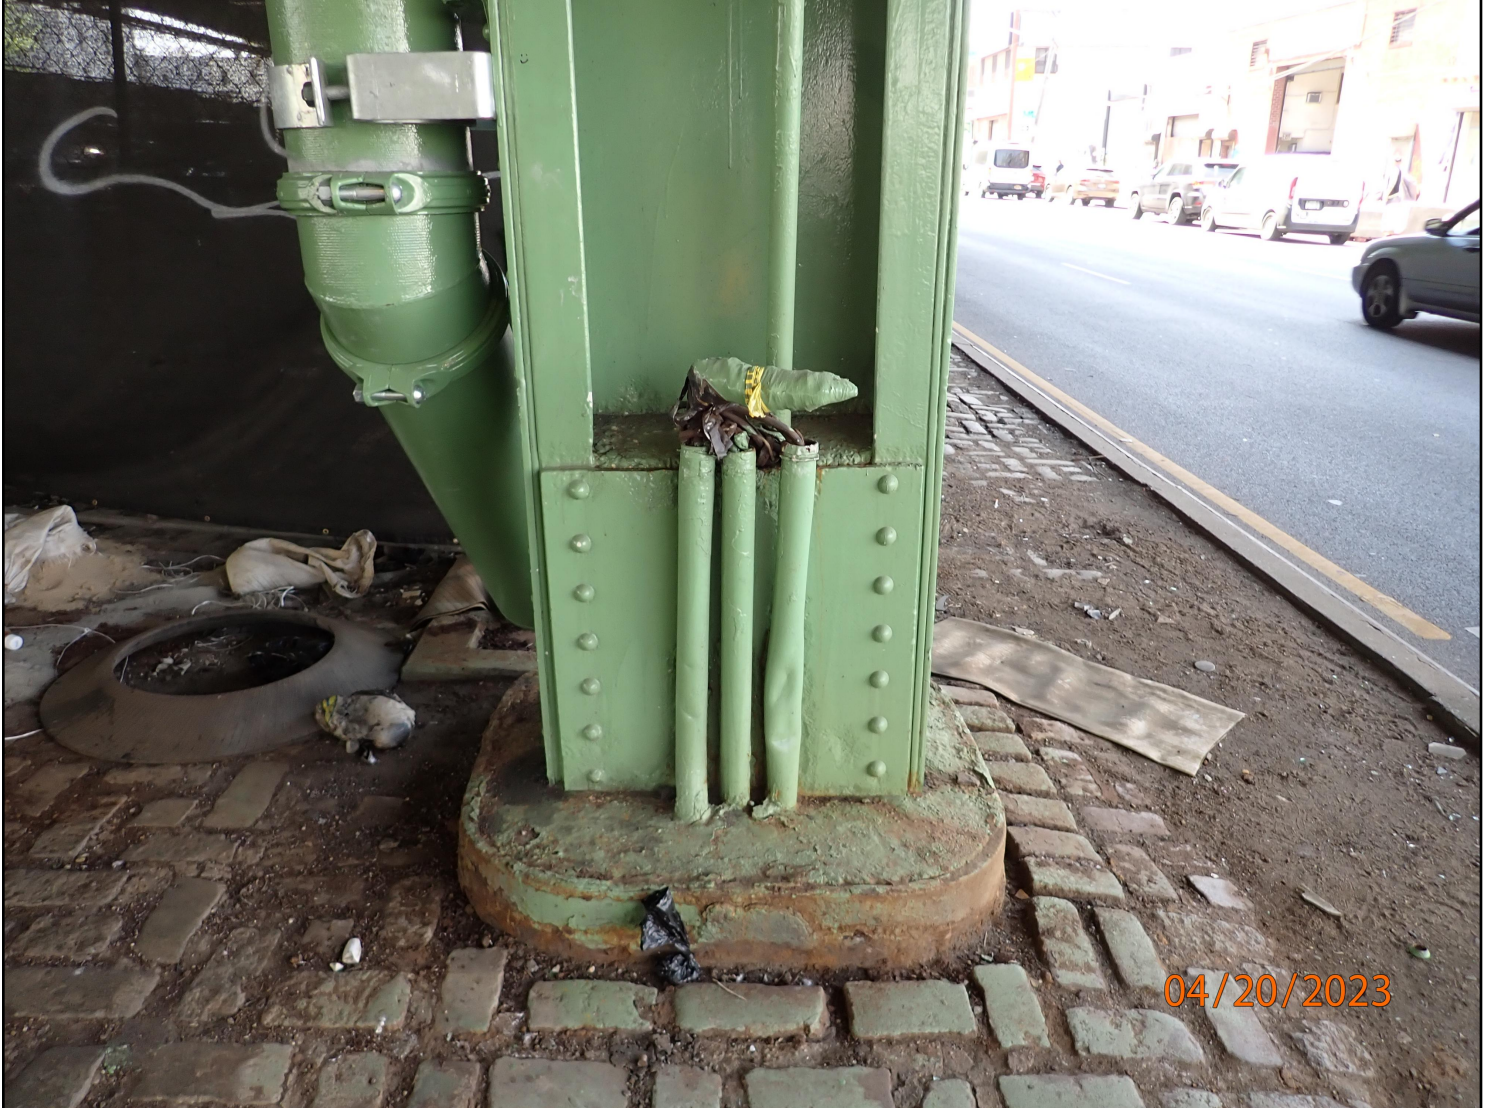
Photo Number: 3

The junction box for the traffic light and attached to Column C1 is broken with exposed electric wires. This location is located at 3' above the ground on the sidewalk and can be accessed by walking. The area is temporarily secured with cones and caution tape.

**Attachment Description:** The sidewalk at the end face of Column C1 of Pier 117 under Span 118. The electrical junction box is broken with exposed wires. The area has been coned off with yellow caution tape. Looking Begin.

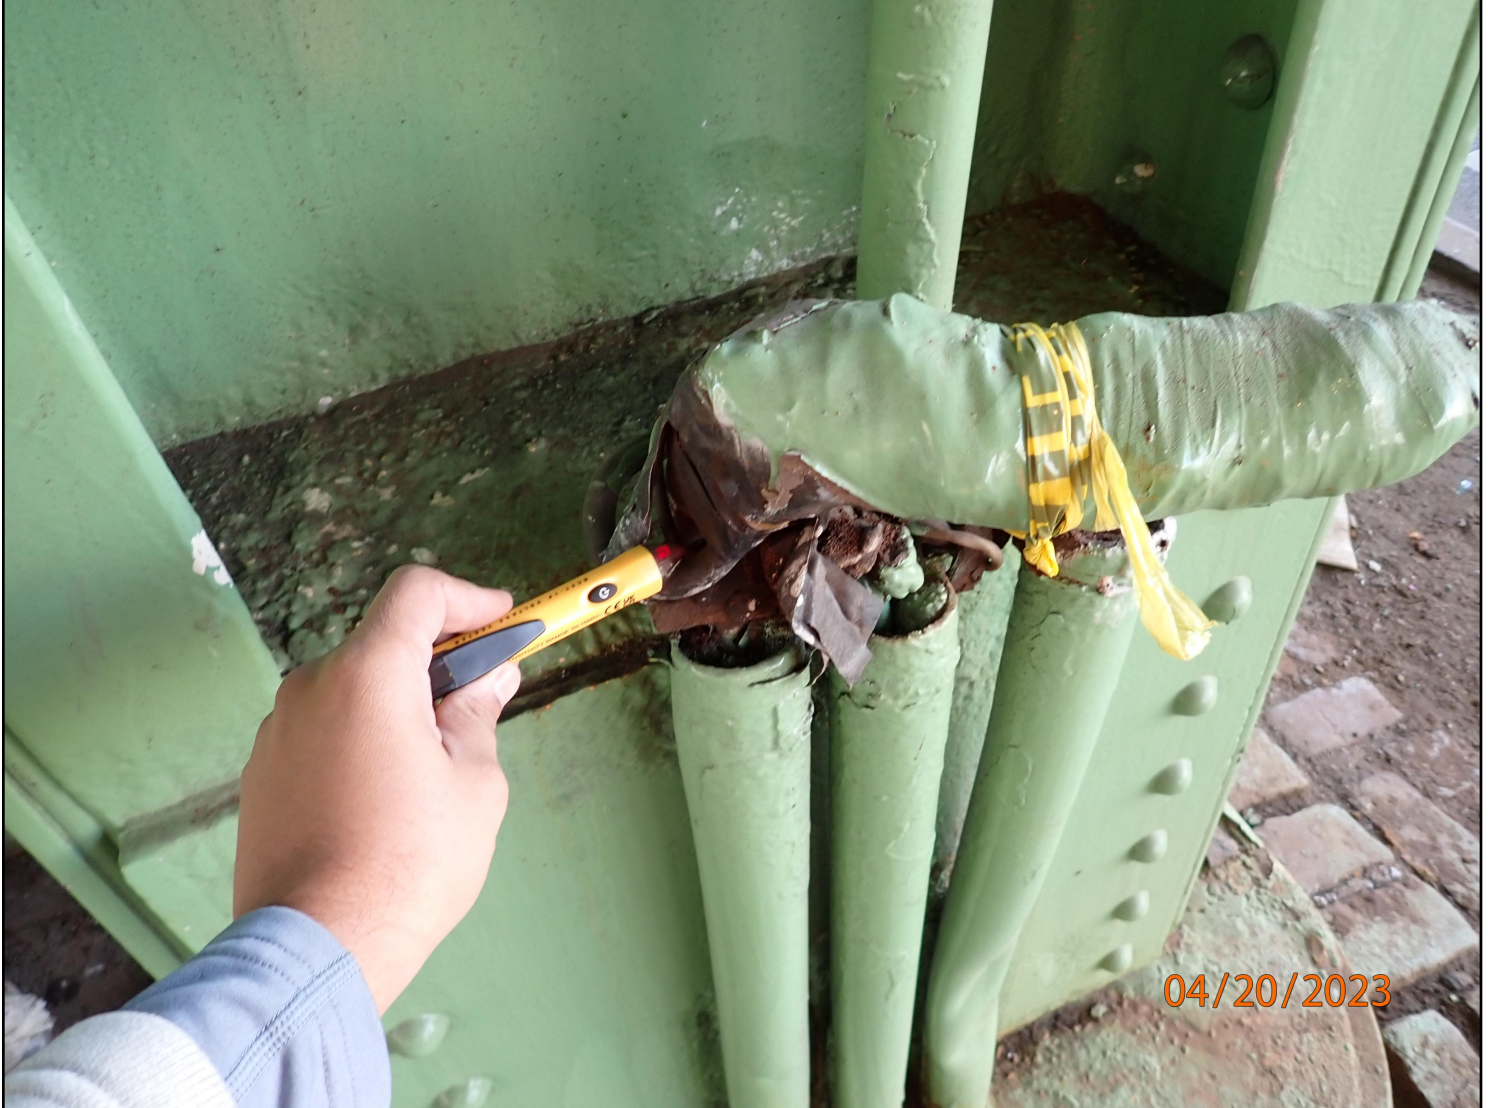
Photo Number: 4

**Attachment Description:** The sidewalk at the end face of Column C1 of Pier 117 under Span 118. The electrical junction box is broken with exposed wires. The area has been coned off with yellow caution tape. Looking Begin-Left.

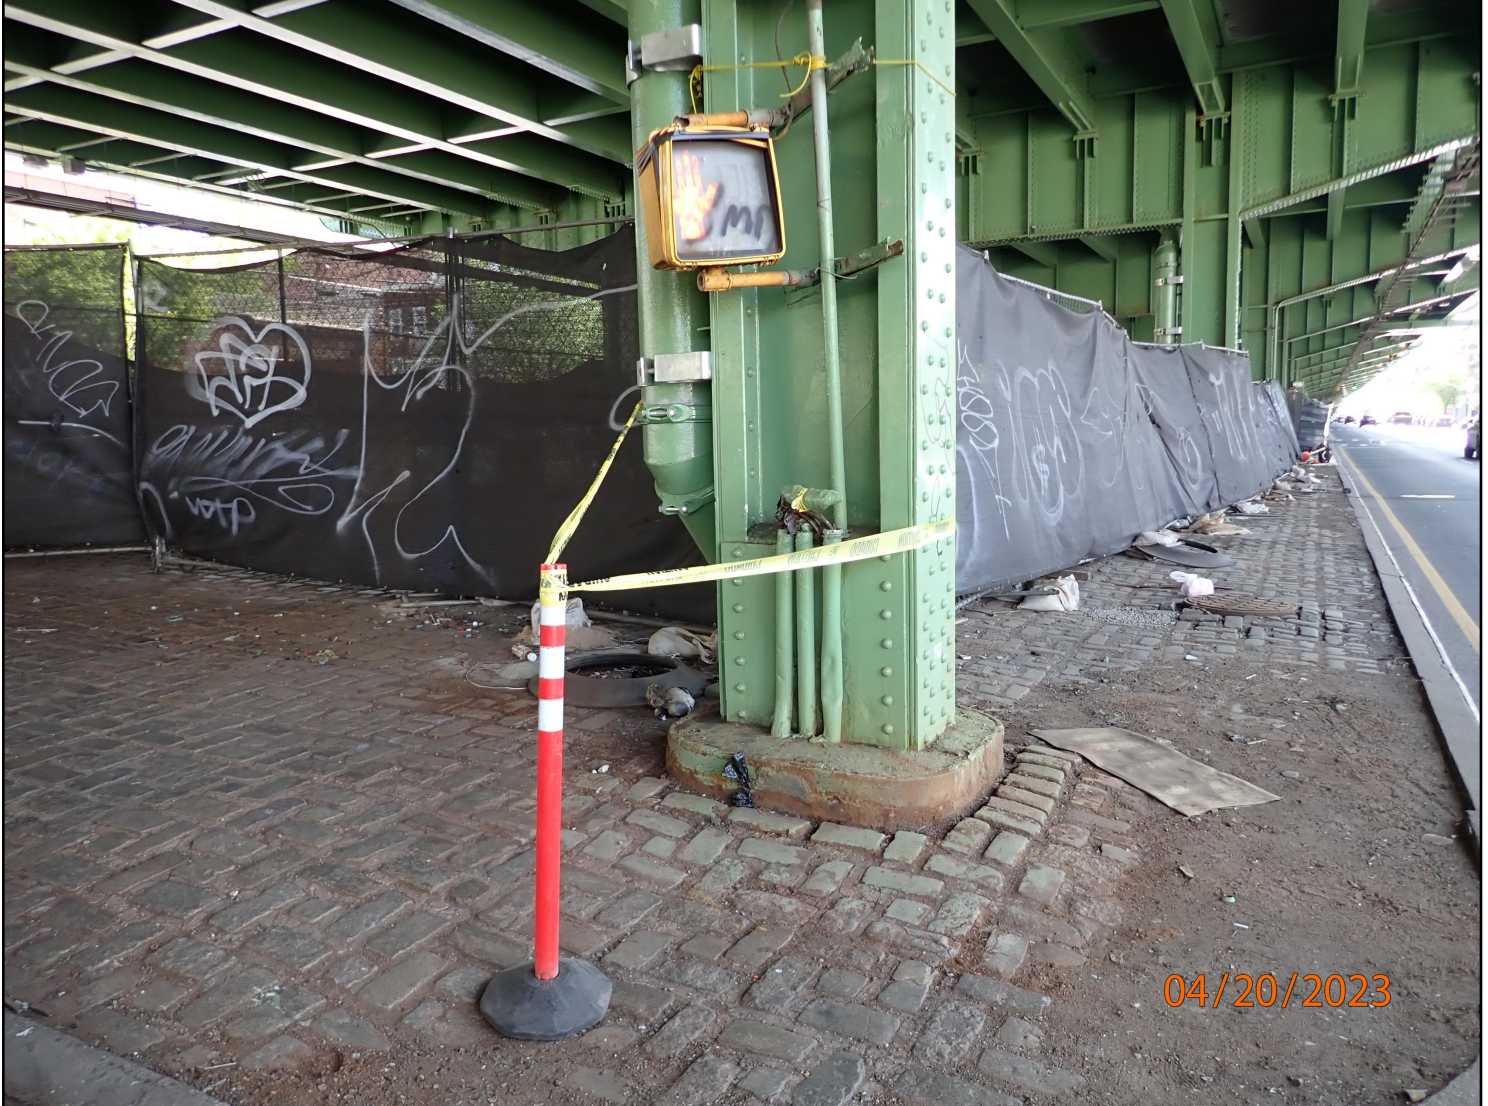
Photo Number: 5

**Attachment Description:** The sidewalk at the end face of Column C1 of Pier 117 under Span 118. The electrical junction box is broken with exposed wires. The area has been coned off with yellow caution tape. Looking Begin-Right.
